Memorandum

DATE: February 13, 2008

SUBJECT: Outfalls, Swan Island Upland Facility – Operable Unit 2
1115-05

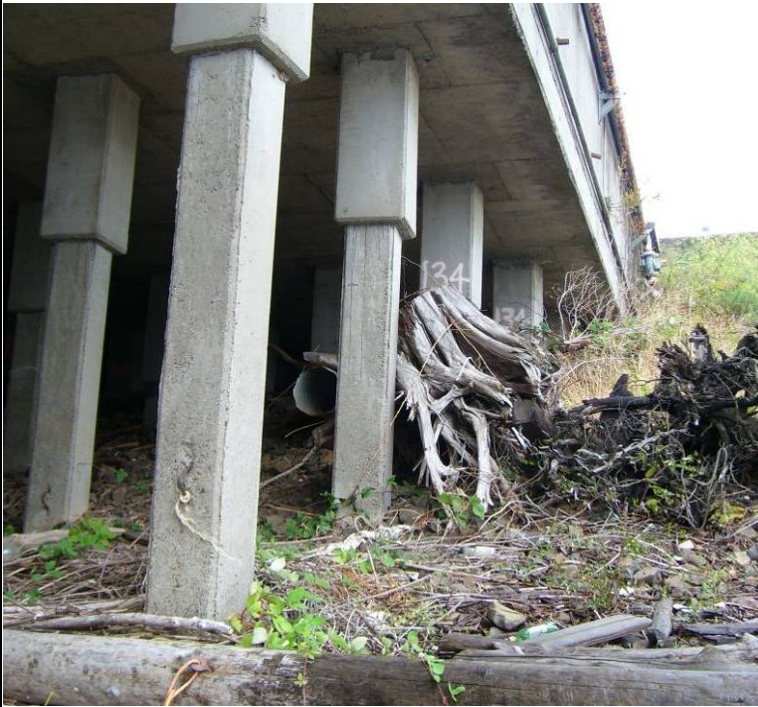
<p>Photo No: 1</p>

Water was observed flowing from outfalls WR-399 and WR-163. This is consistent with our expectations based on the recent storm events and the apparent connections to upland storm water system components. No flow was observed from the other four pipe locations (described by Integral as abandoned). Outfall WR-158 is located north of OU2 on Operable Unit 1 (OU1). Outfall WR-163 is located southeast of OU2; it is connected to one catch basin located on the east end of OU2 and one or more catch basins located on the adjacent Freightliner parking lot.

<p>Photo Date: October 3, 2007</p>	
<p>Orientation: North</p>	
<p>Description: Outfall WR-158 under OU1 pier. No flow. See Figure 3 for photograph orientation.</p>	
<p>Photo No: 2</p>

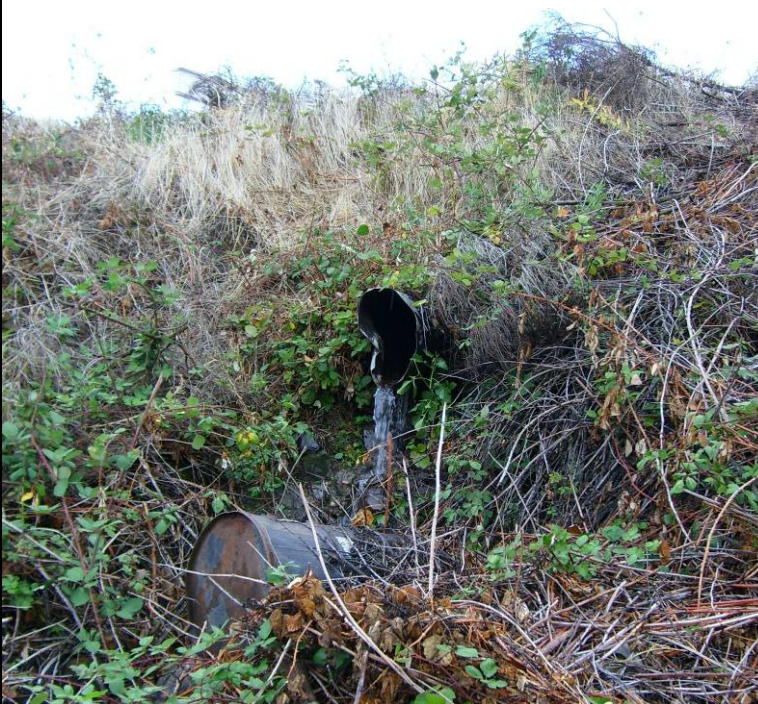
<p>Photo Date: October 3, 2007</p>	
<p>Orientation: Northeast</p>	
<p>Description: Outfall WR-399. Flowing water. See Figure 3 for photograph orientation.</p>

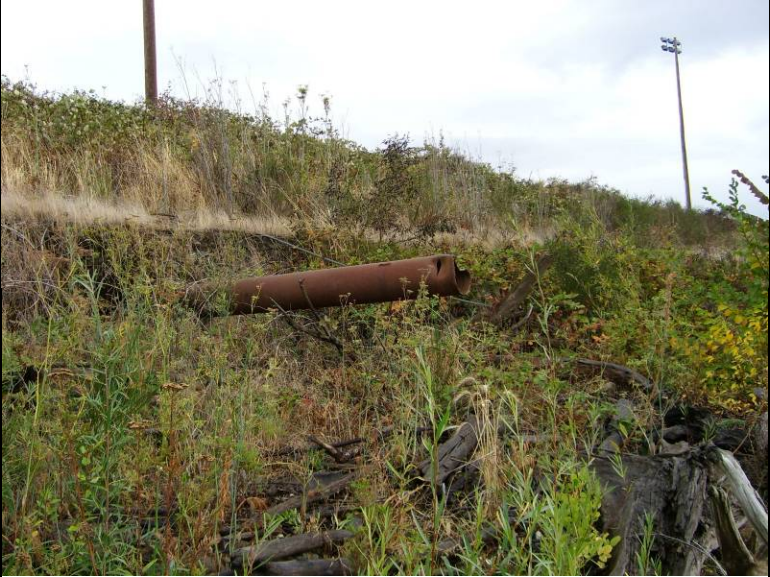
Photo No: 5

WR-159a. The 1942 overlay shows a combined sanitary and storm sewer line which crossed OU2 to an outfall located in the vicinity of WR-159a, which was observed in the field.

Photo Date: October 3, 2007	
Orientation: Northeast	
Description: Outfall WR-159. No flow. See Figure 3 for photograph orientation.

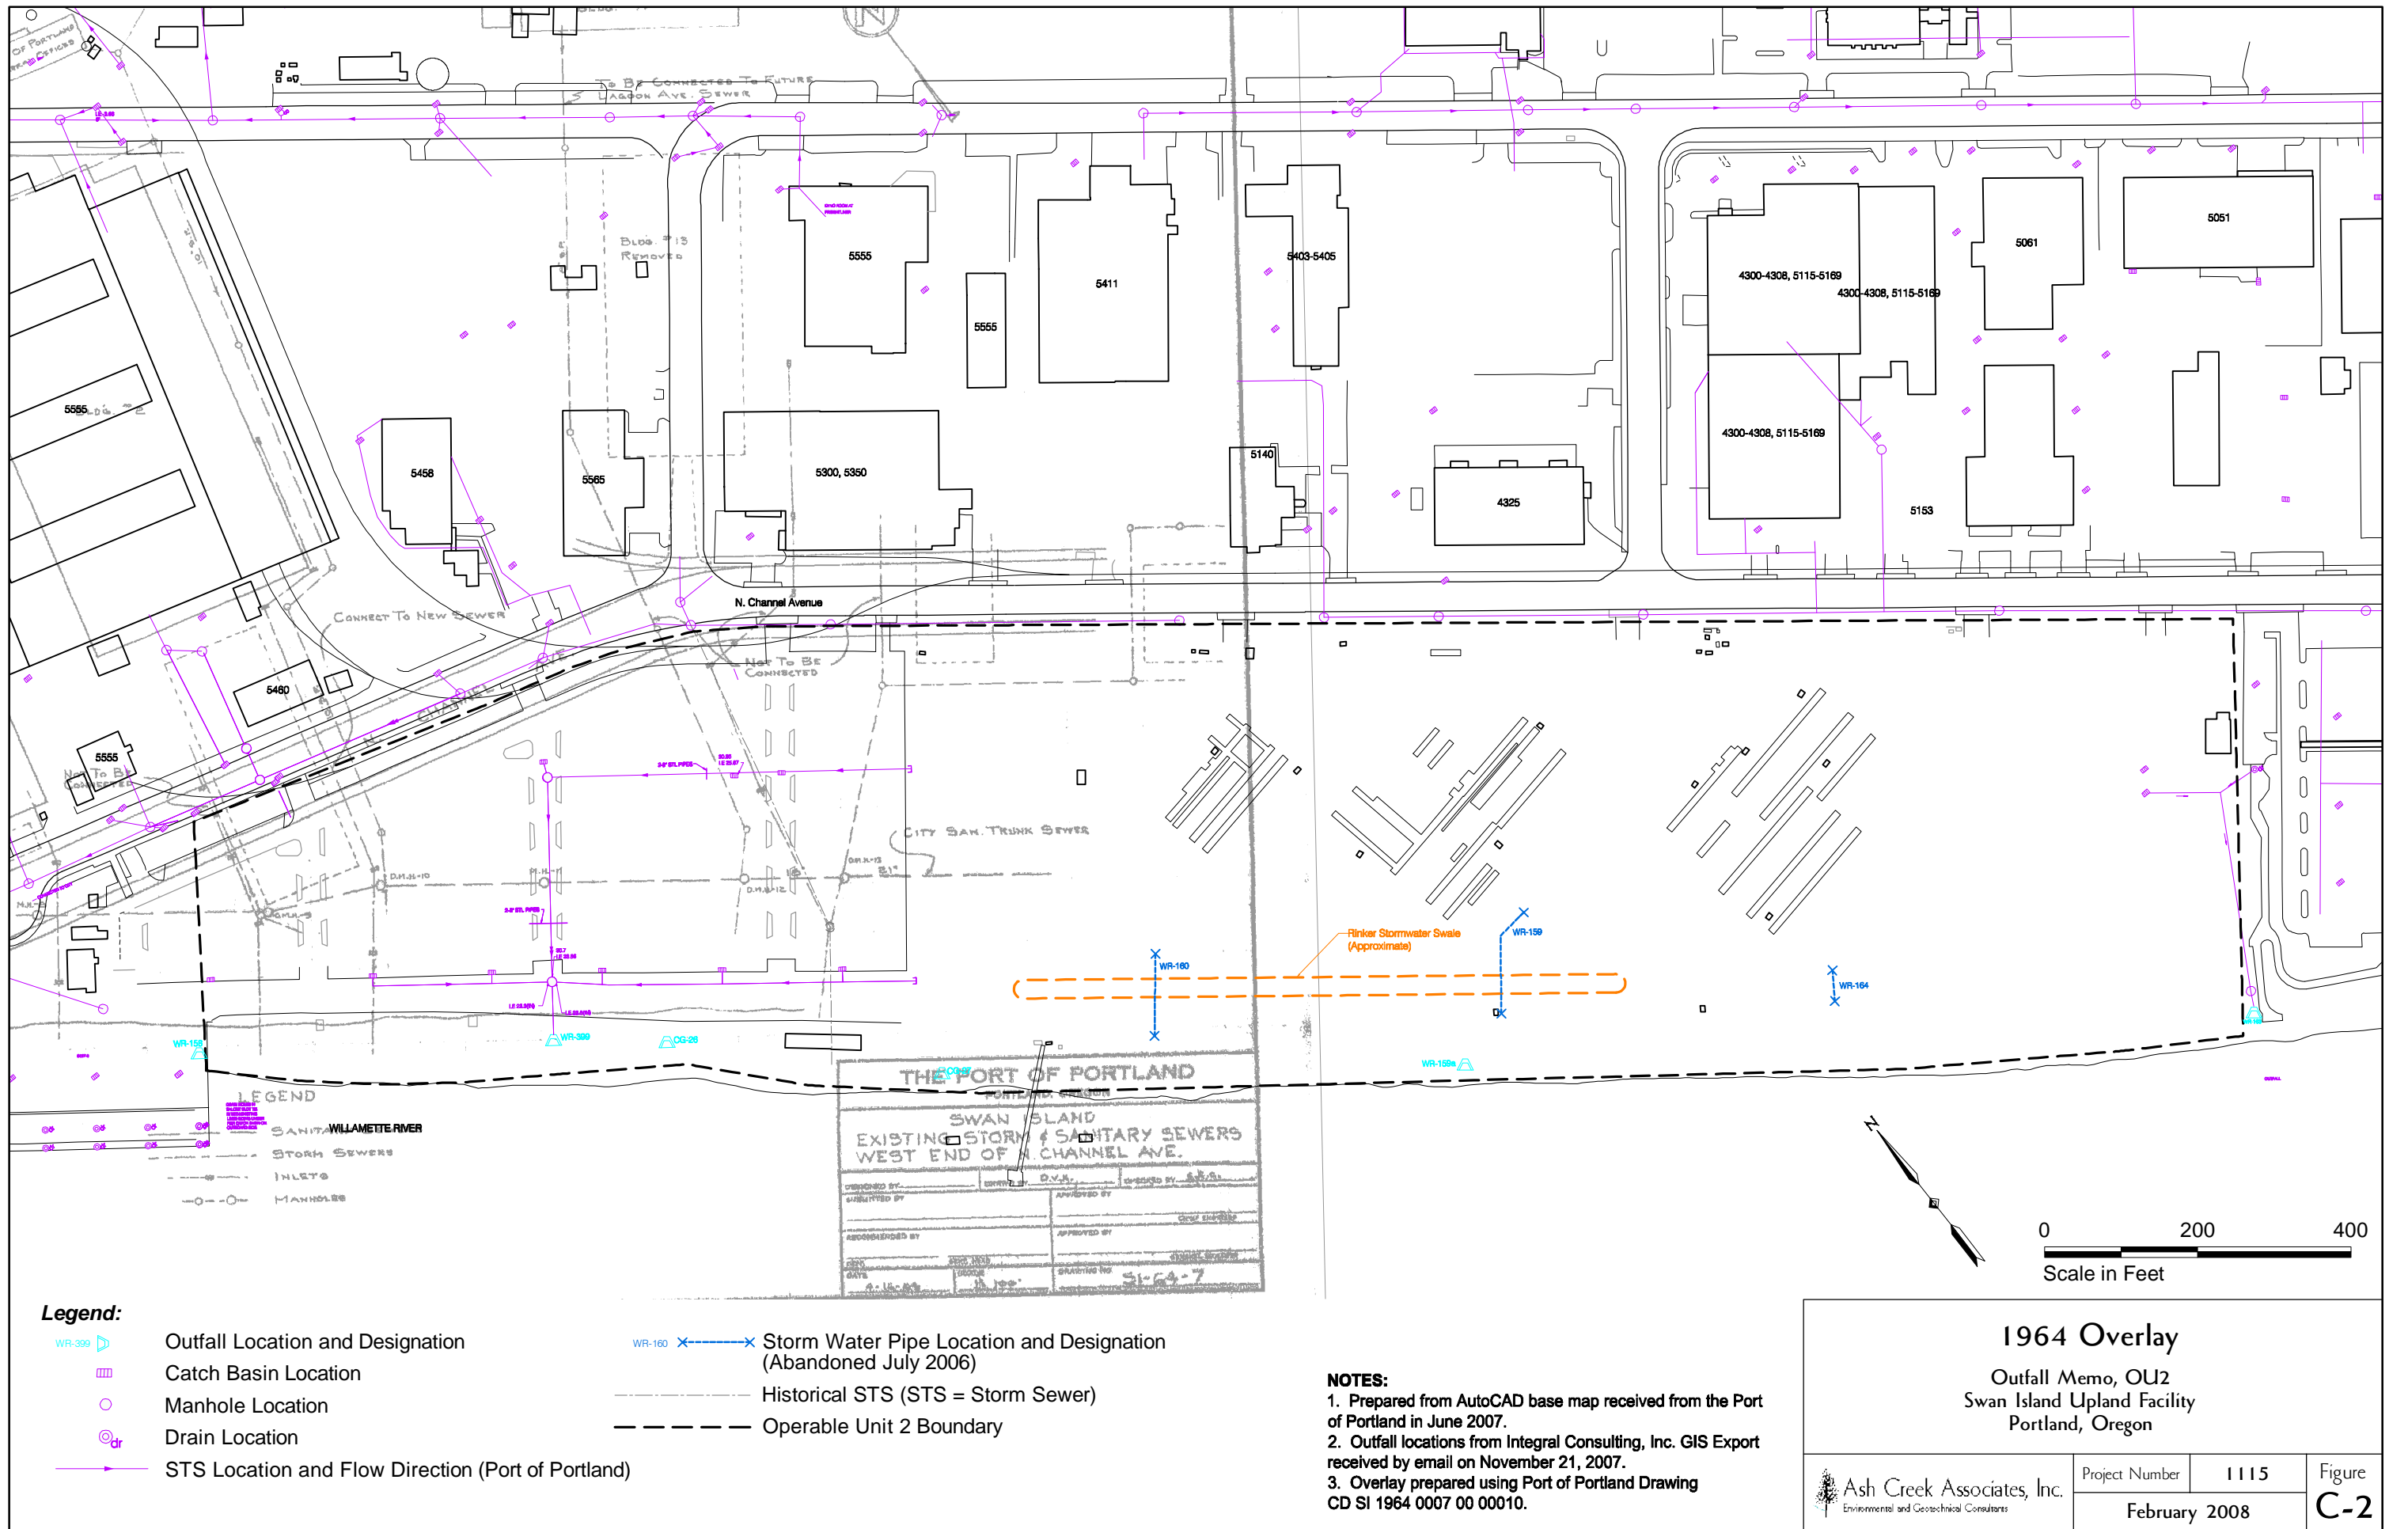
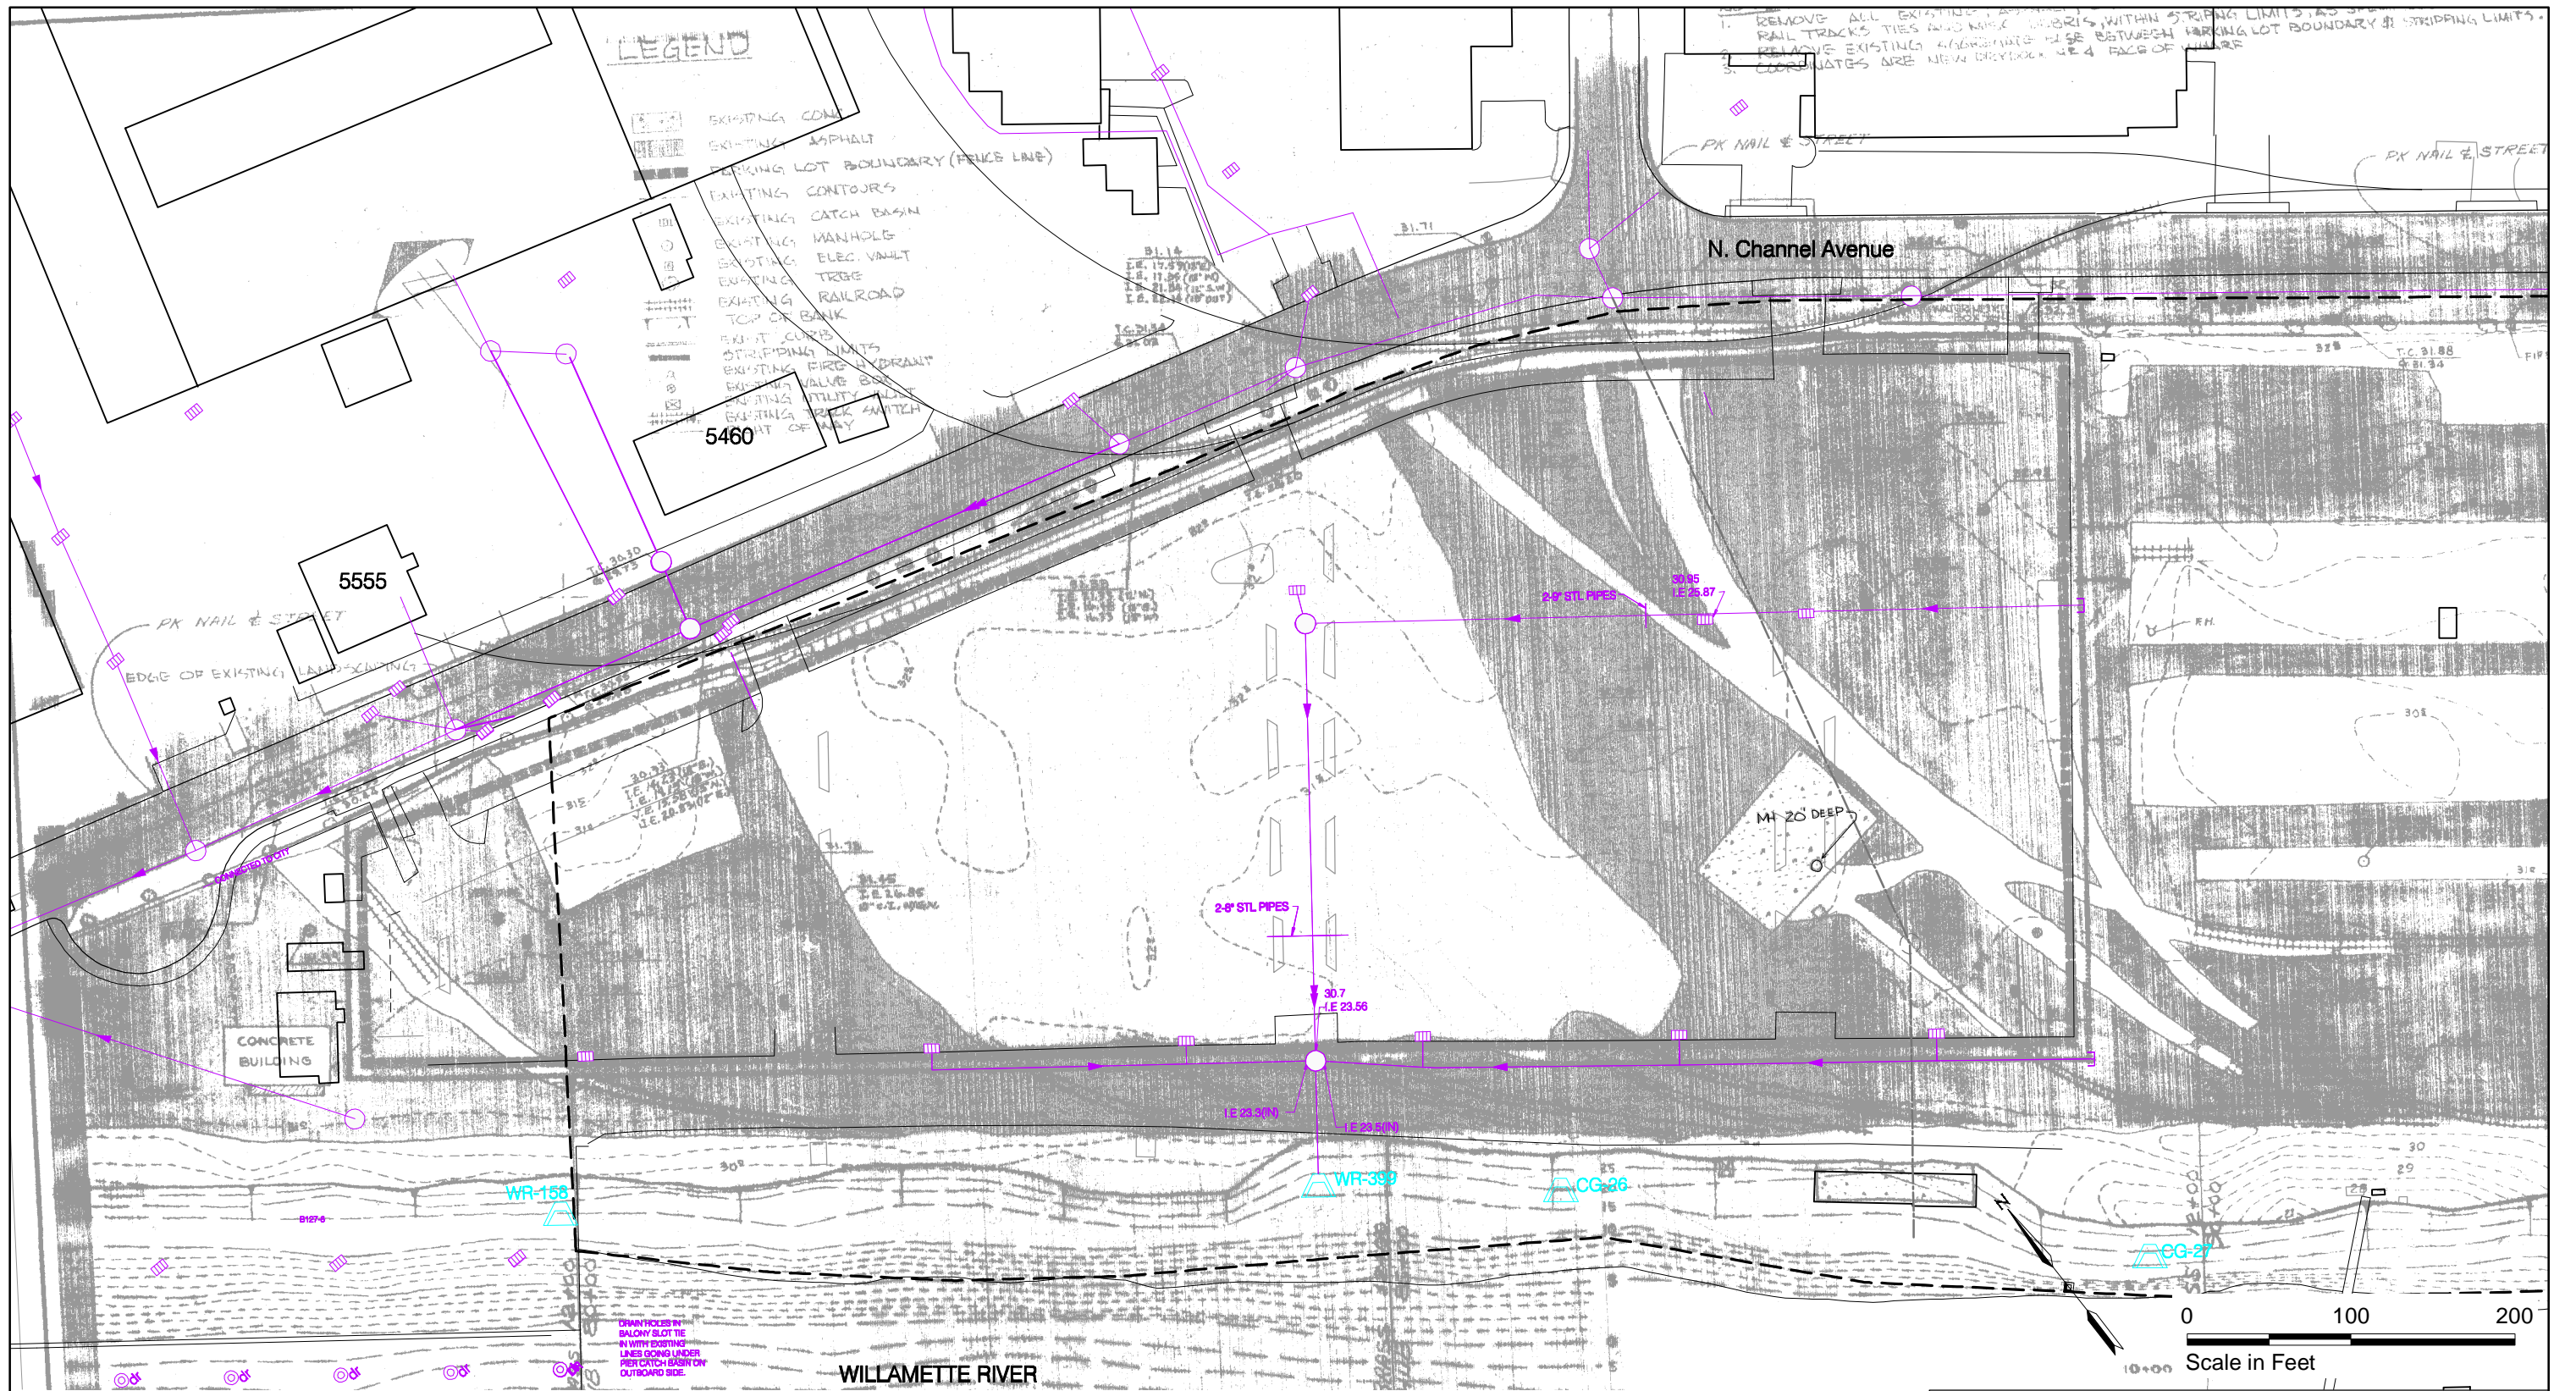
1977 Overlay

- **1977.** The 1977 drawing presents as-built information for site features that were removed as part of the construction of the current parking lot. The overlay shows a deep manhole (20-foot) in the vicinity of the historical storm sewer/outfall that was removed. The historical storm sewer was likely removed as part of the construction activities.

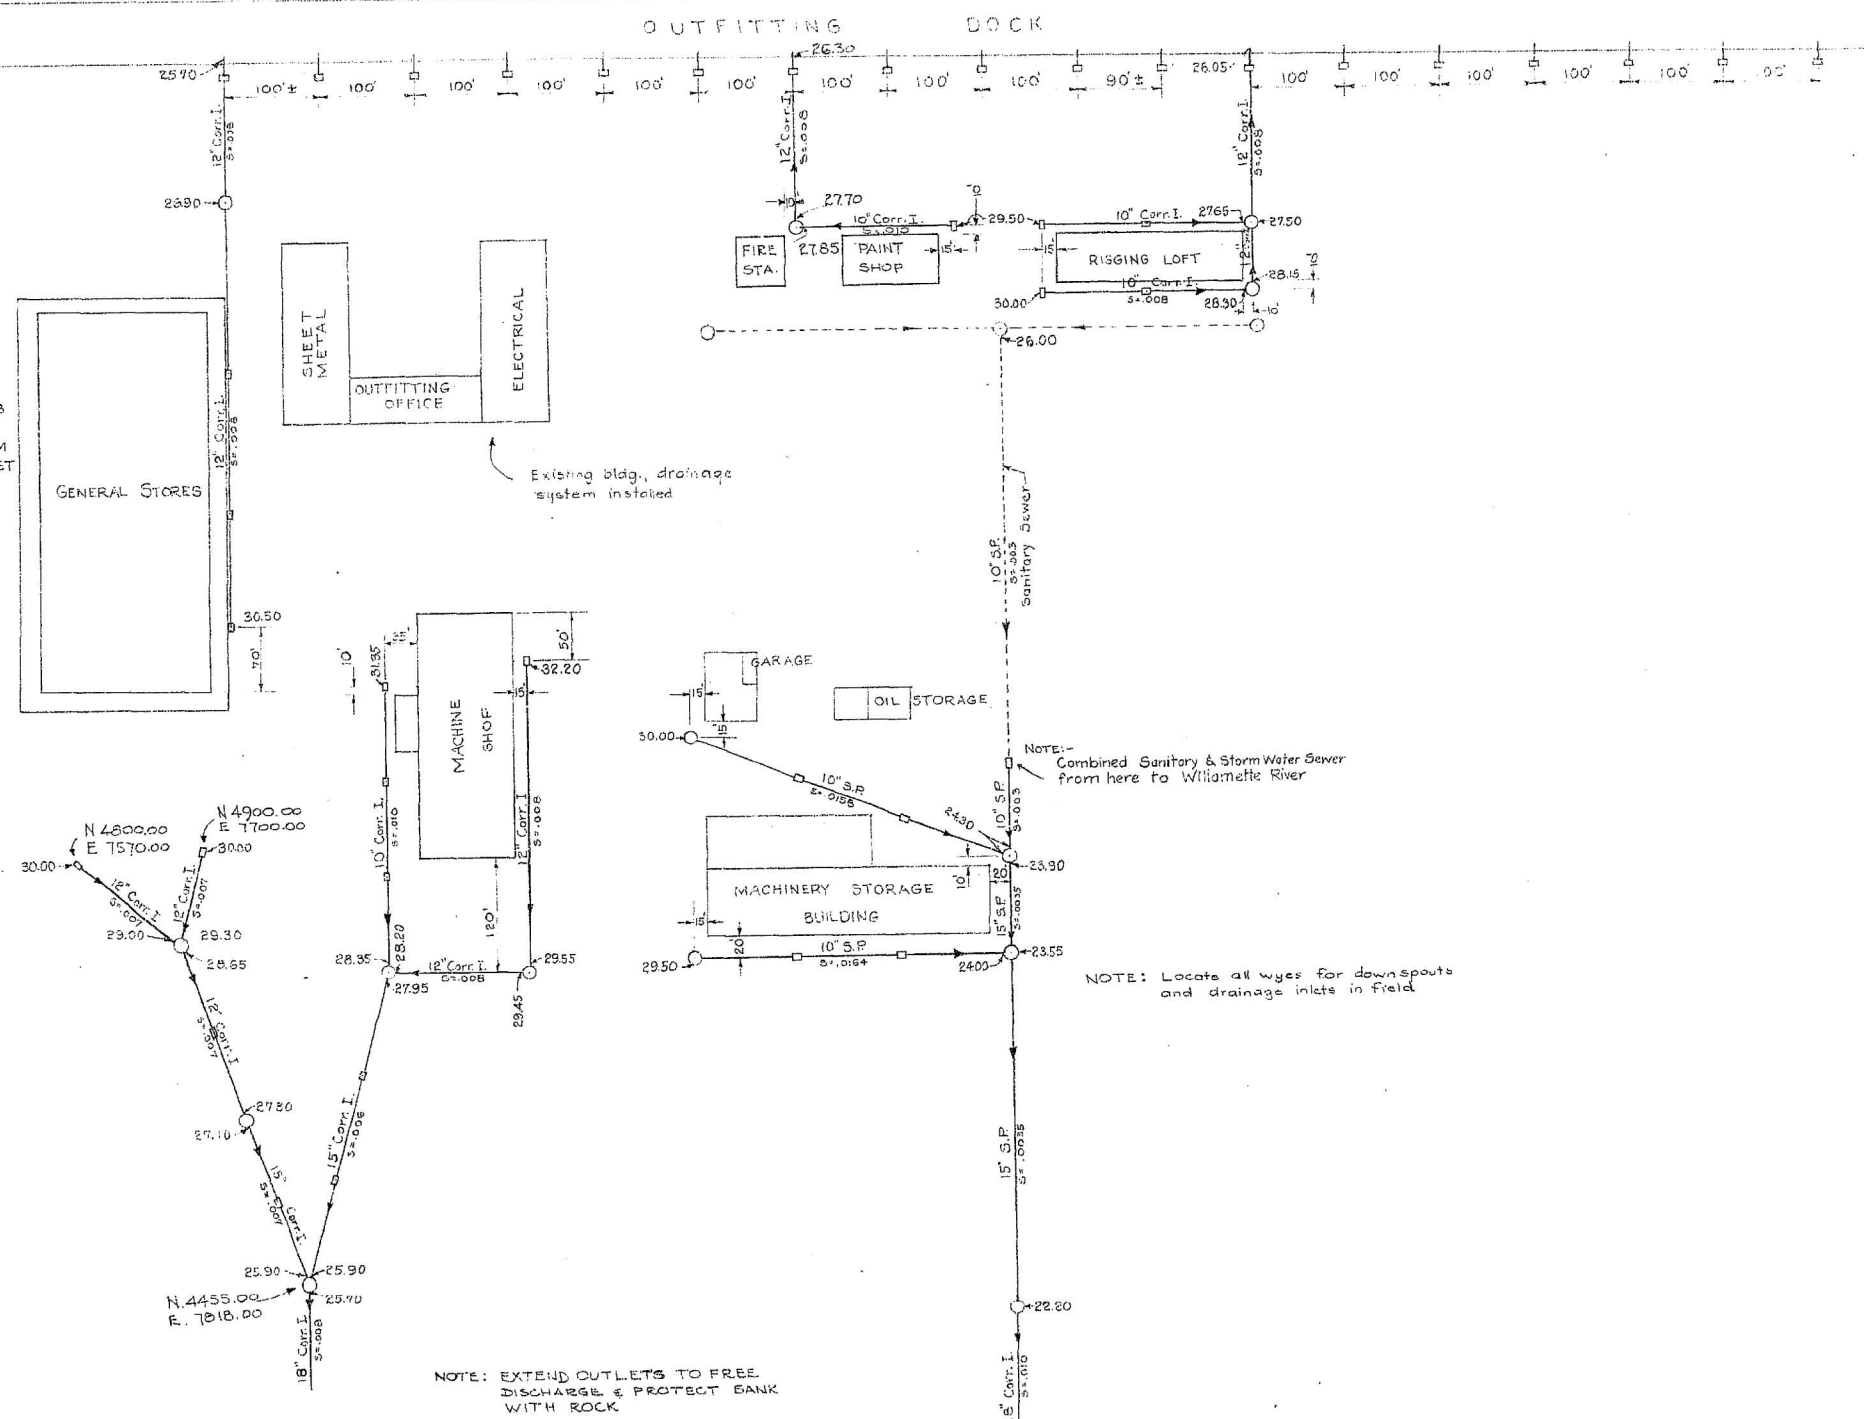
- **1942.** The overlays of buildings and utilities were not consistent. This could be attributed to differences in design vs. as-built drawings, surveys, and other factors. A storm sewer feature which resembles the historical storm sewer/outfall from the Port base map (as described above) is present (a "Y"-shaped configuration). The "Y"-shaped storm feature was overlaid on the historical storm sewer/outfall and correlated well.

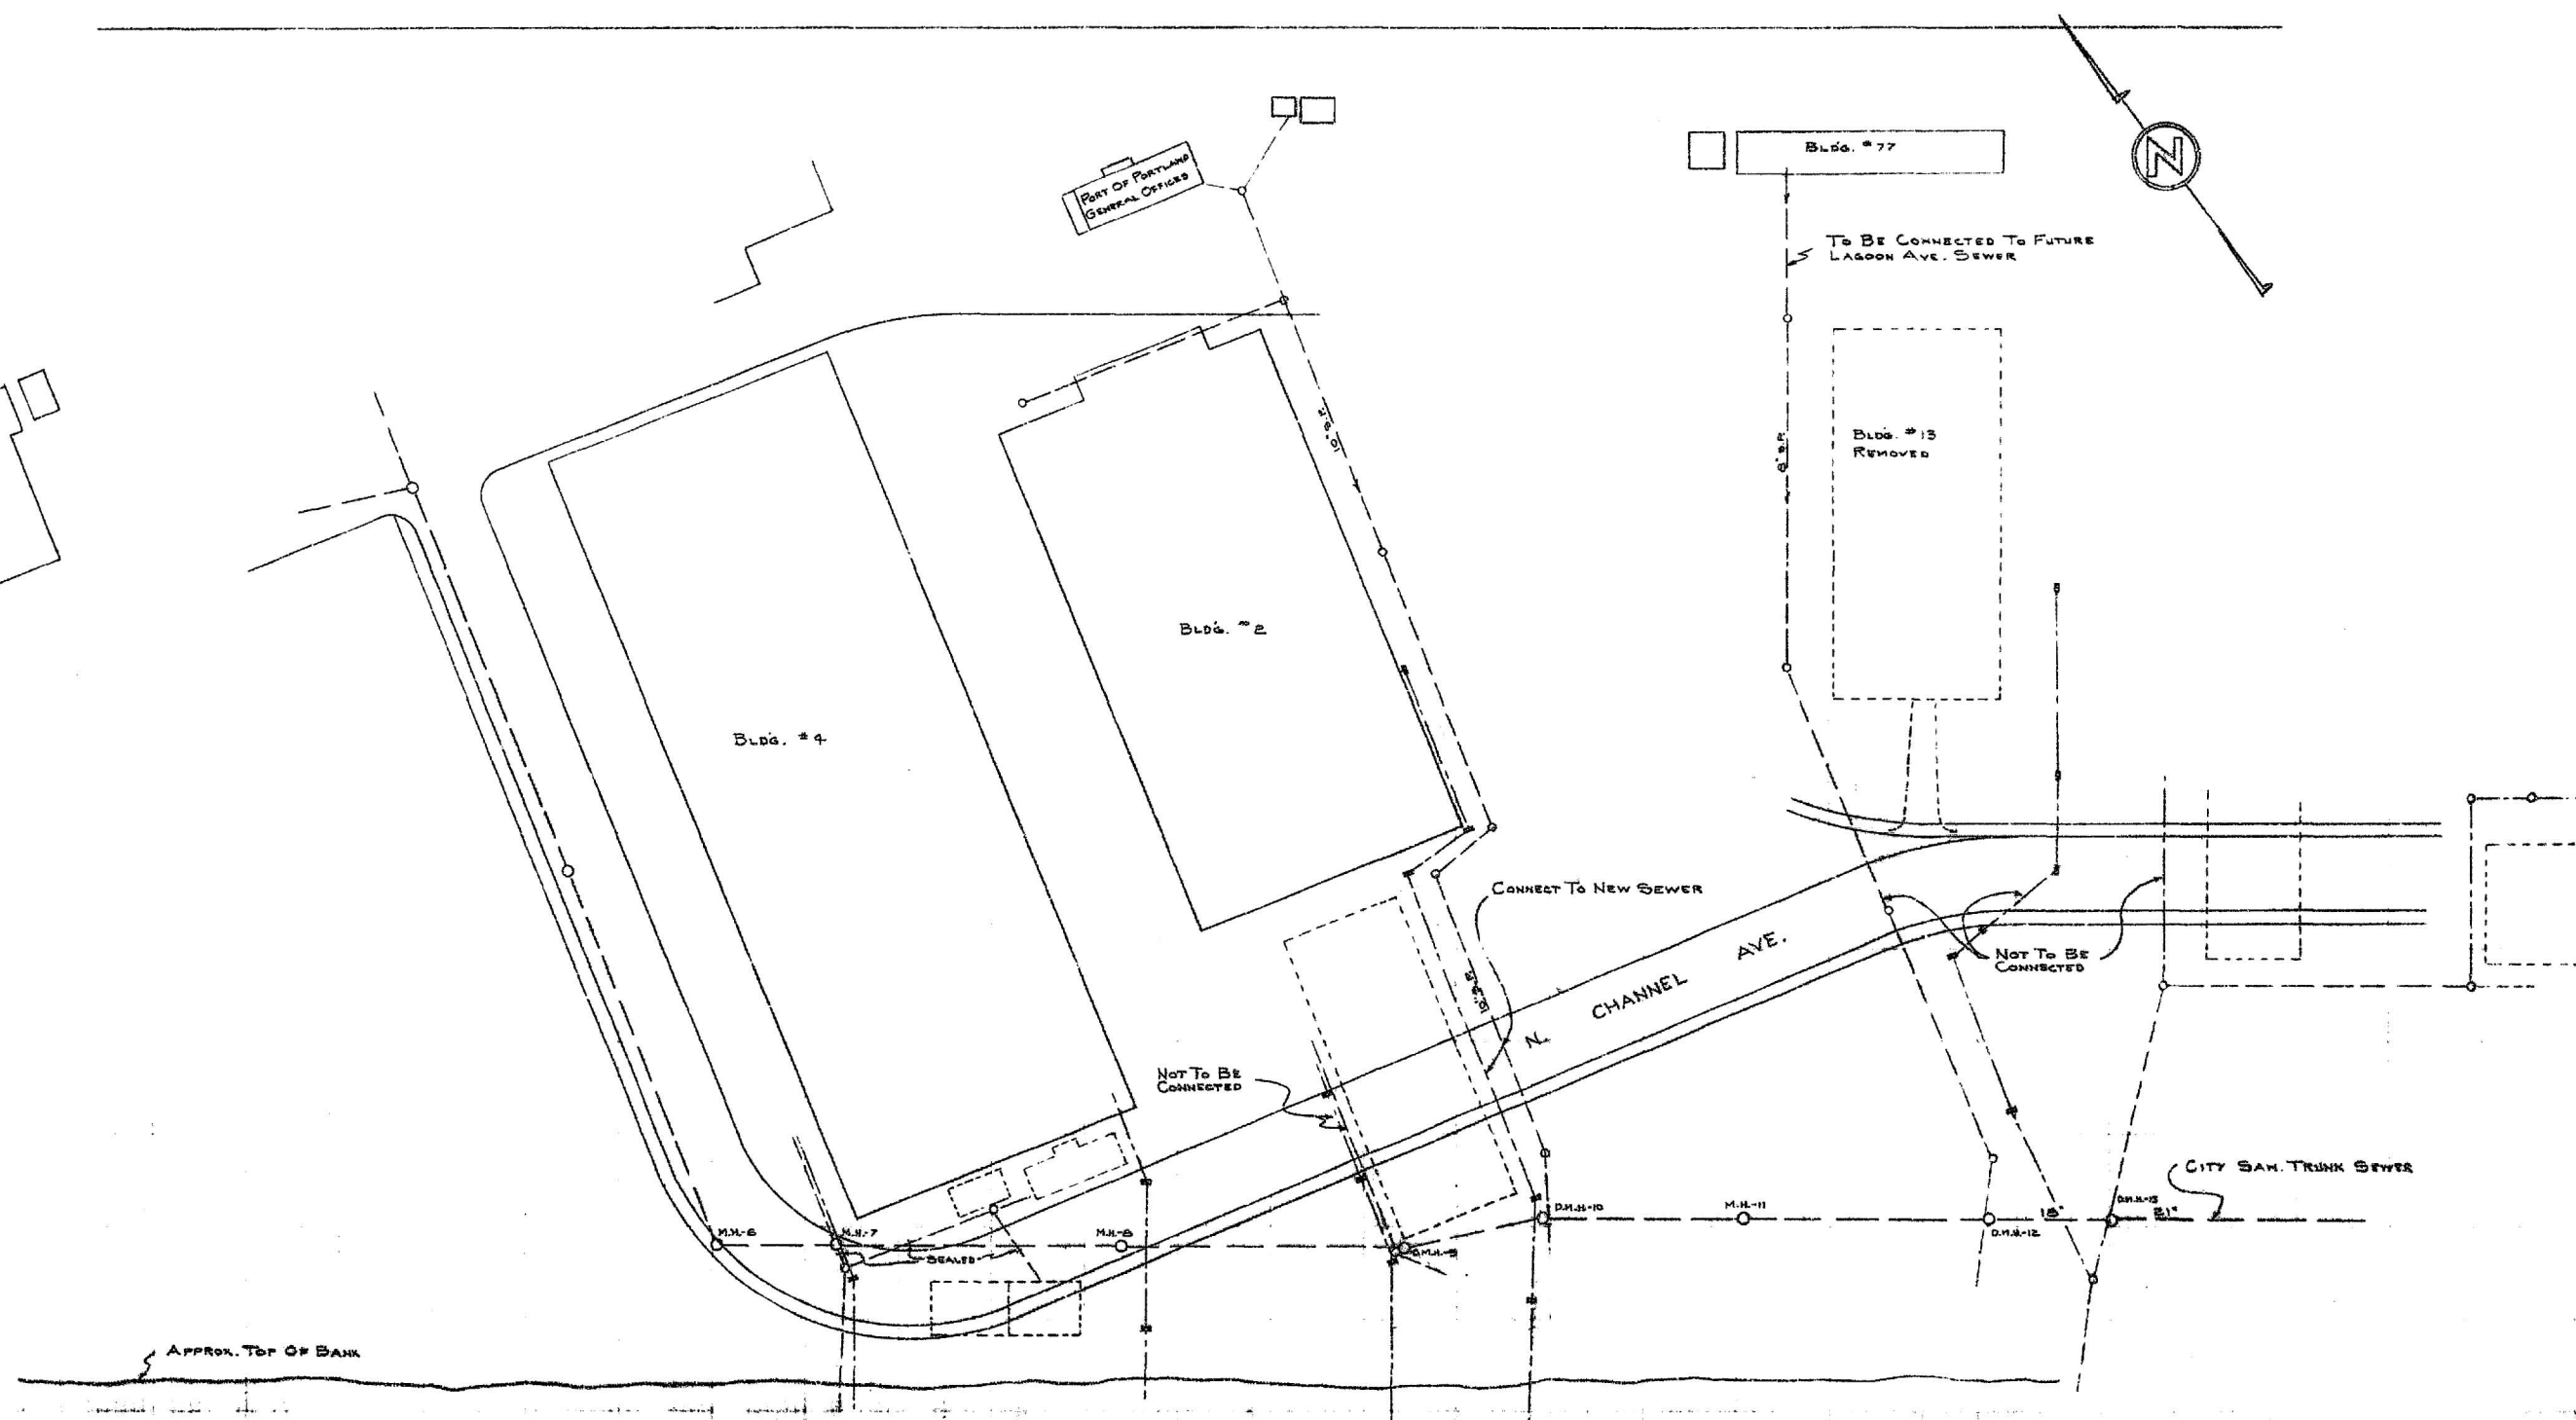
- **1964.** The "Y"-shaped storm sewer configuration is also present. The eastern portion of the "Y"-shaped feature is designated as a sanitary sewer utility although, by this period, it would have been connected to the shown sanitary sewer trunk interceptor. The trunk sewer was installed in 1954 under the original Channel Avenue.
